Historic Congressional Cemetery 2009 Burial Vault Conservation Projects

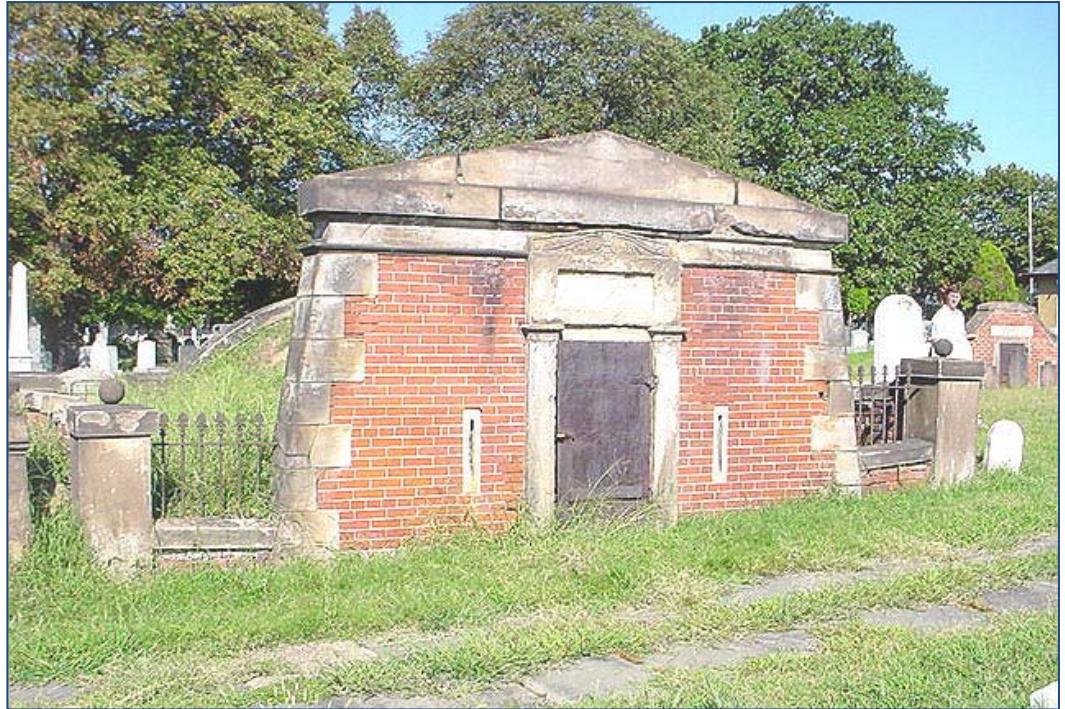
Inside the vaults, there is a wide variety of 'interior designs'. Some have open shelves that hold several caskets, some have several crypts into which single caskets are

placed, and some are just large rooms where caskets were placed atop each other. Most of the older vaults, like those we are repairing this year, are the open room plan.

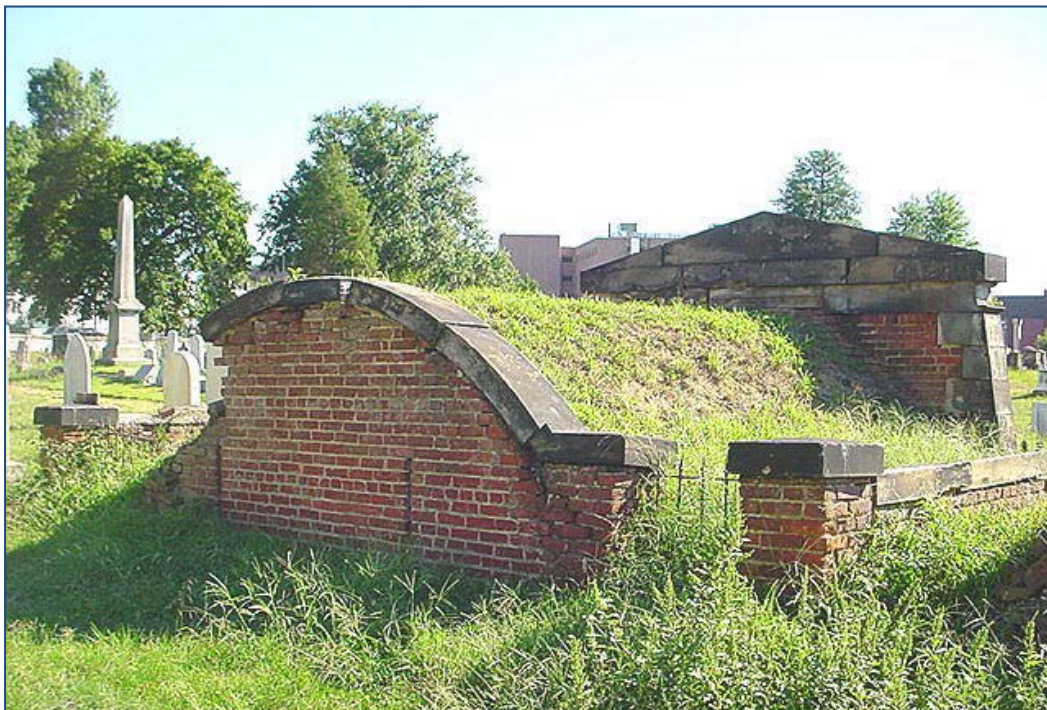
The problem with lime based mortars is that they can succumb to the nitric and sulfuric acids carried in modern rainfall. As the rain dissolves the calcium carbonate, the bonding quality of the mortar disappears and the sand in the mortar simply blows away. The photos here illustrate the loss of mortar in one vault over just five years. Stronger mortars will eventually destroy the bricks themselves.

That’s the phenomenon we’ve been responding to at Congressional. The historic brick burial vaults that imbue the cemetery with much of its character are suffering from the effects of acid rain. As seen in the photo below, a major portion of the brick wall has fallen from the rear facade of this vault.

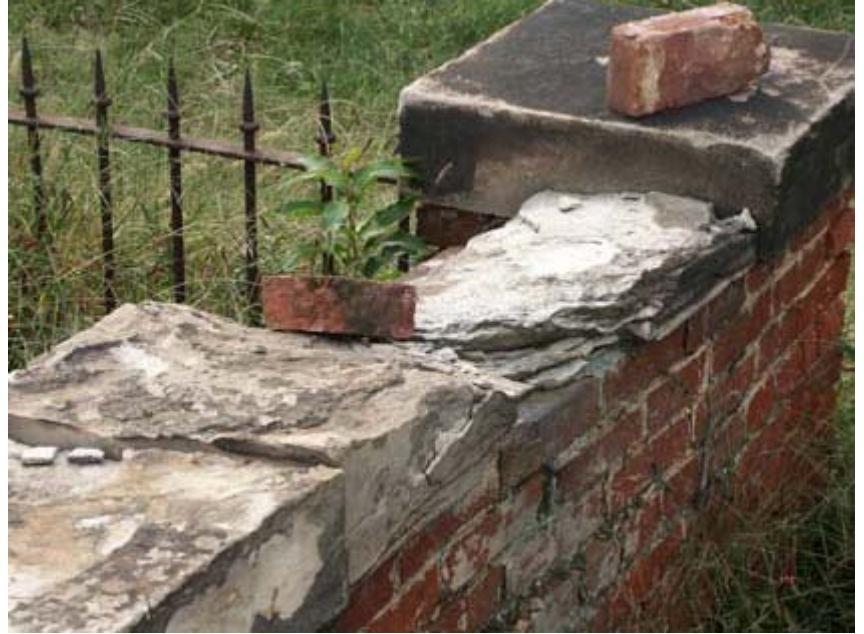
Another key material that makes up these vaults is sandstone, the same sandstone from the same quarry as the stone from which the U.S Capitol Building was made. The Aquia Creek Sandstone is a beautiful stone but it's a soft stone that has not stood the test of time. Many of the capstones that line the low rise walls adjoining these structures have degenerated back into a looser sedimentary state - crumbled beyond recognition.

They need to be replaced.

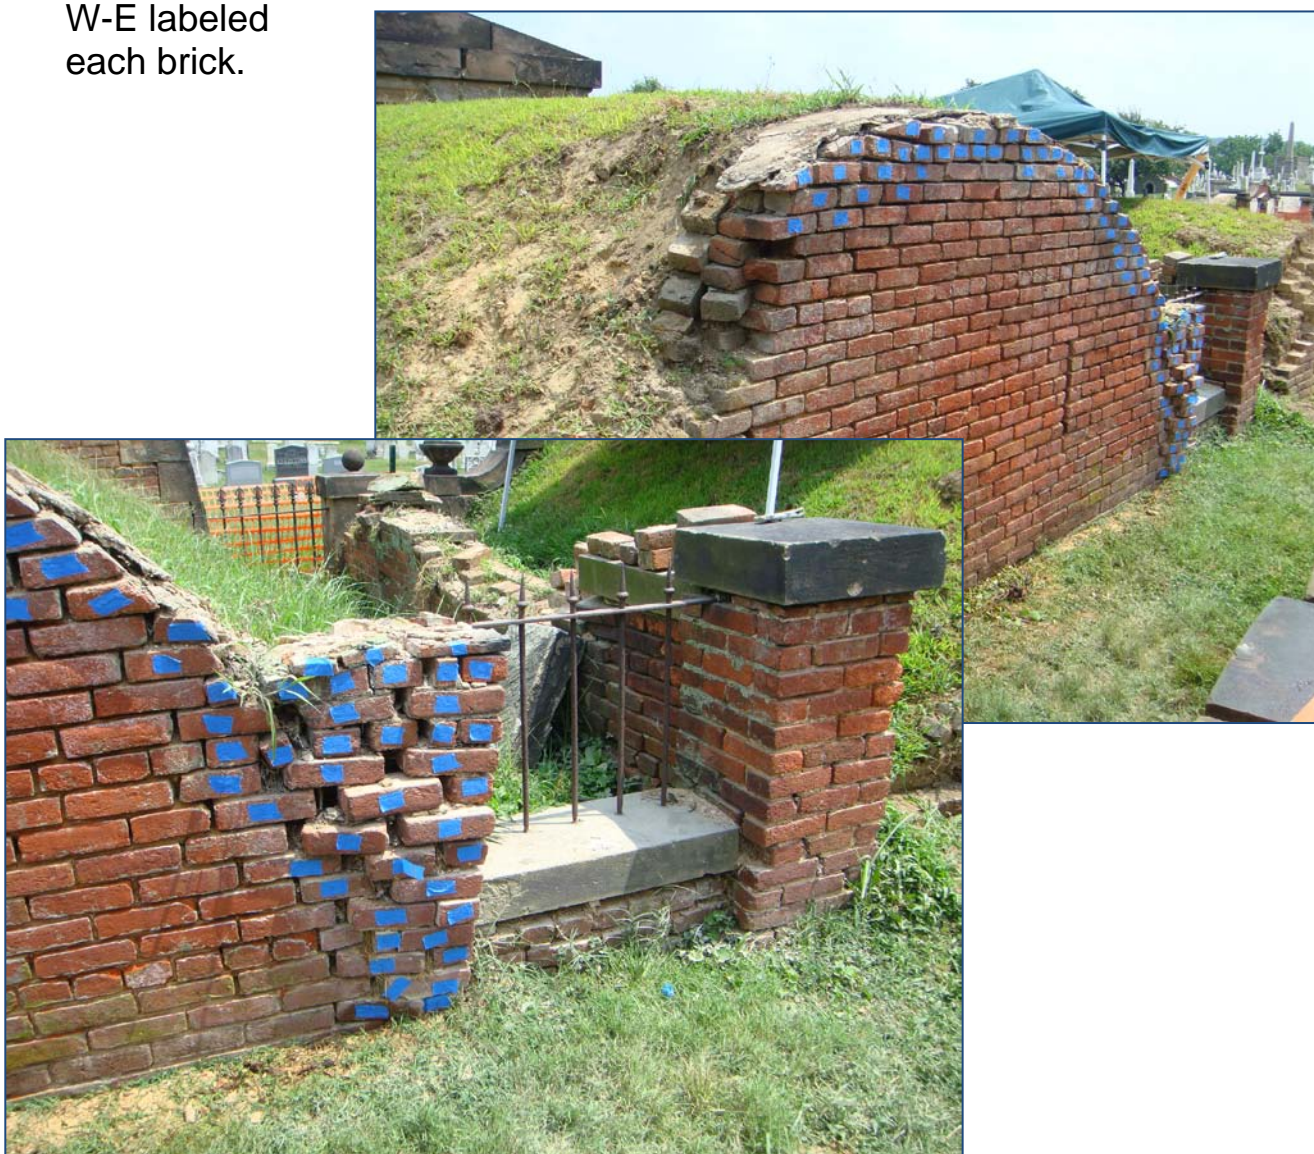
The west façade of this vault, shown below, was so bad that most of the wall had to be taken down and rebuilt. To make sure all the bricks fit back in where they were supposed to, like a jigsaw puzzle, W-E labeled each brick.

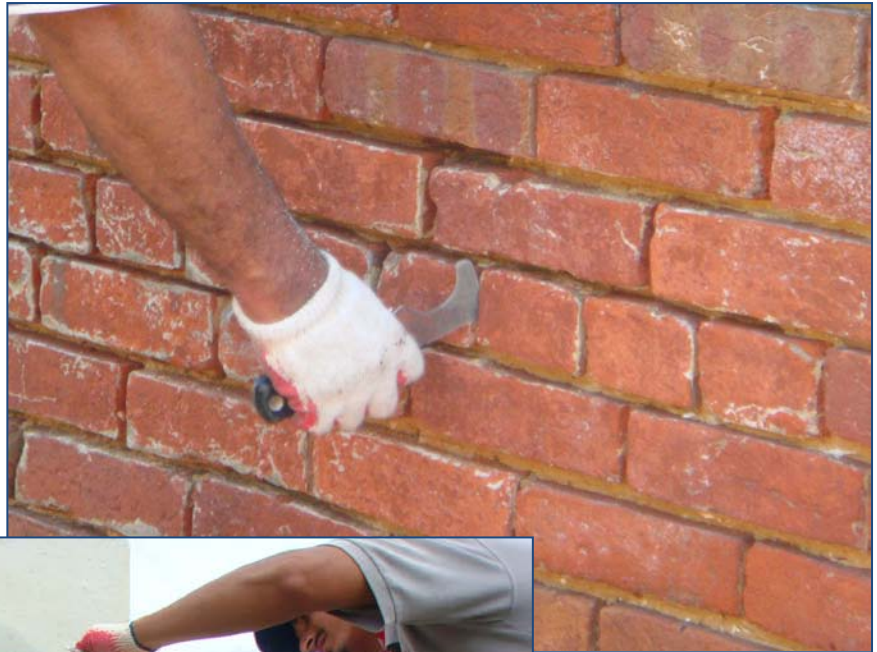
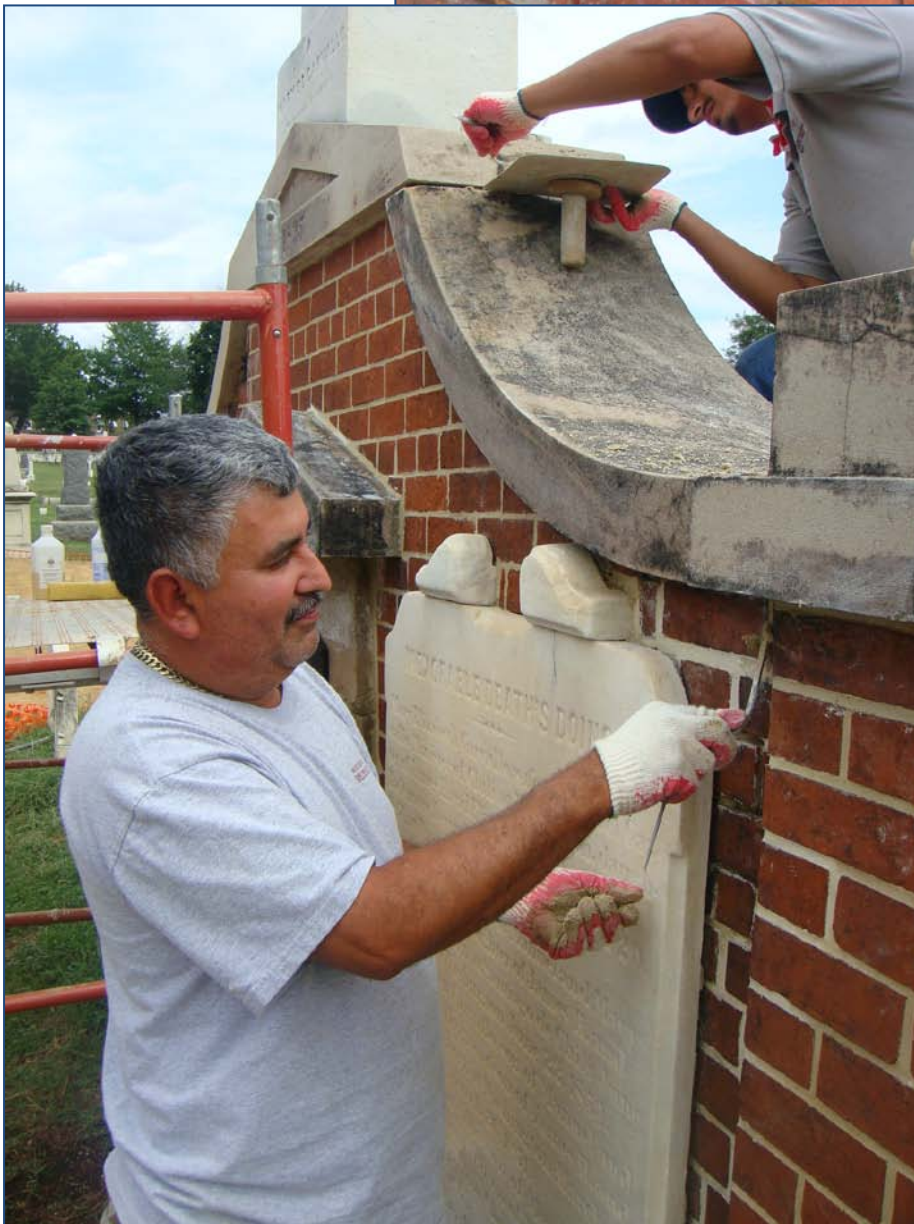
Where the wall is solid enough, the outer layer of mortar is scraped away and a new layer of mortar – of the same chemical composition – is pressed into the gap between the bricks.

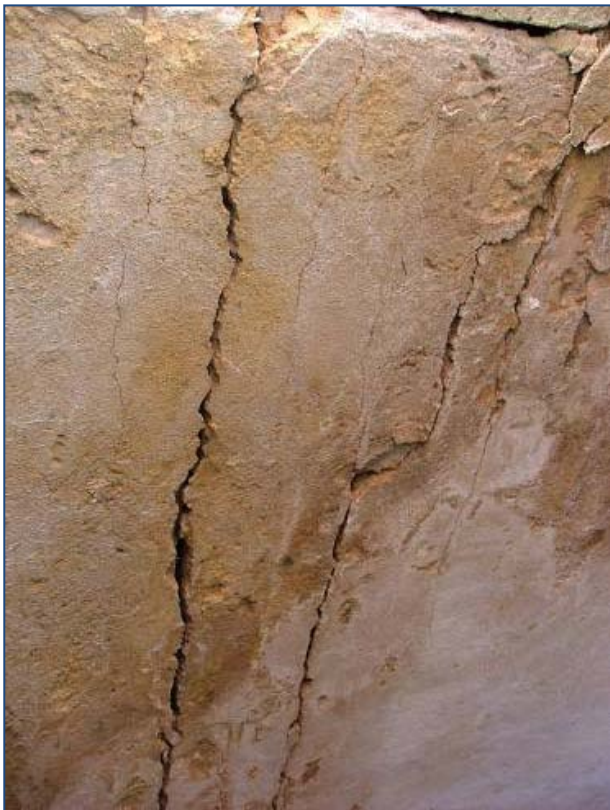
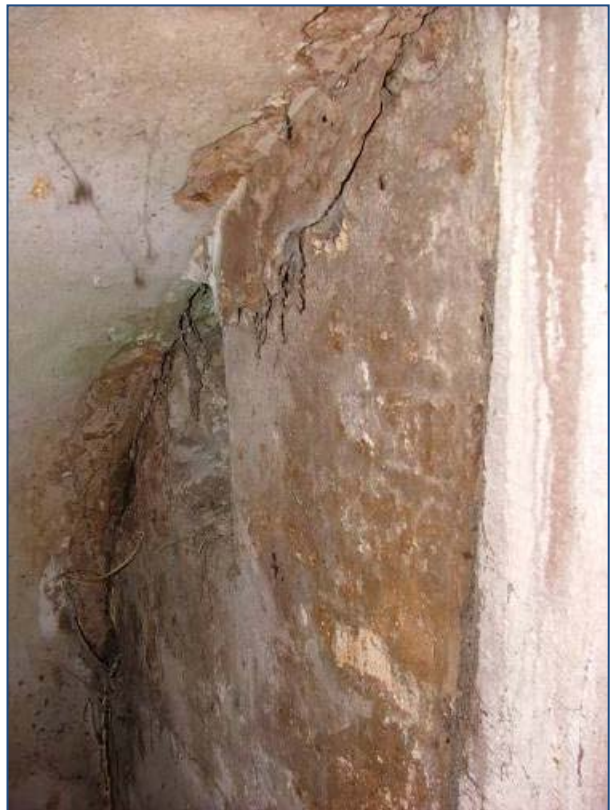
When we opened the iron doors, which had not been opened in decades, what we found was disconcerting. Disconcerting in two respects. First, we found large cracks across the ceiling parging (a plaster-like coating) and grass roots dangling from the ceiling – a clear indication that the roof had been compromised. Water and roots indicate significant structure problems ahead.

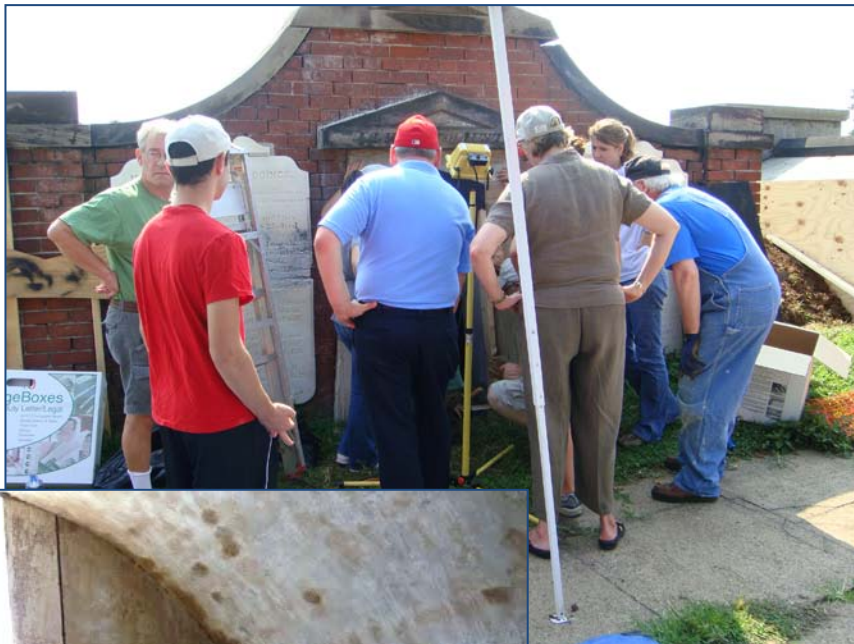
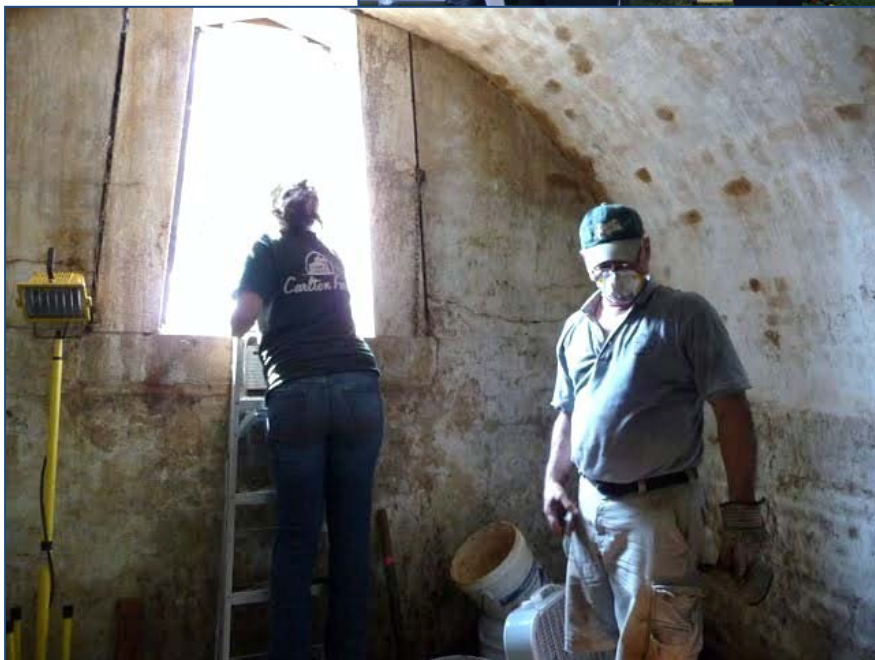
In the photo on the right, volunteers and scientist gather for instruction from Dr. Douglas Owsley, who is down inside the tomb. In the lower photo, the interior is cleared of casket debris and remains.

So when we repair old brick vaults, we ask the Smithsonian to take on the task of moving the remains. The Cemetery gets the work done so restoration efforts may proceed; the Smithsonian gets access to important primary source material for the advancement of science.

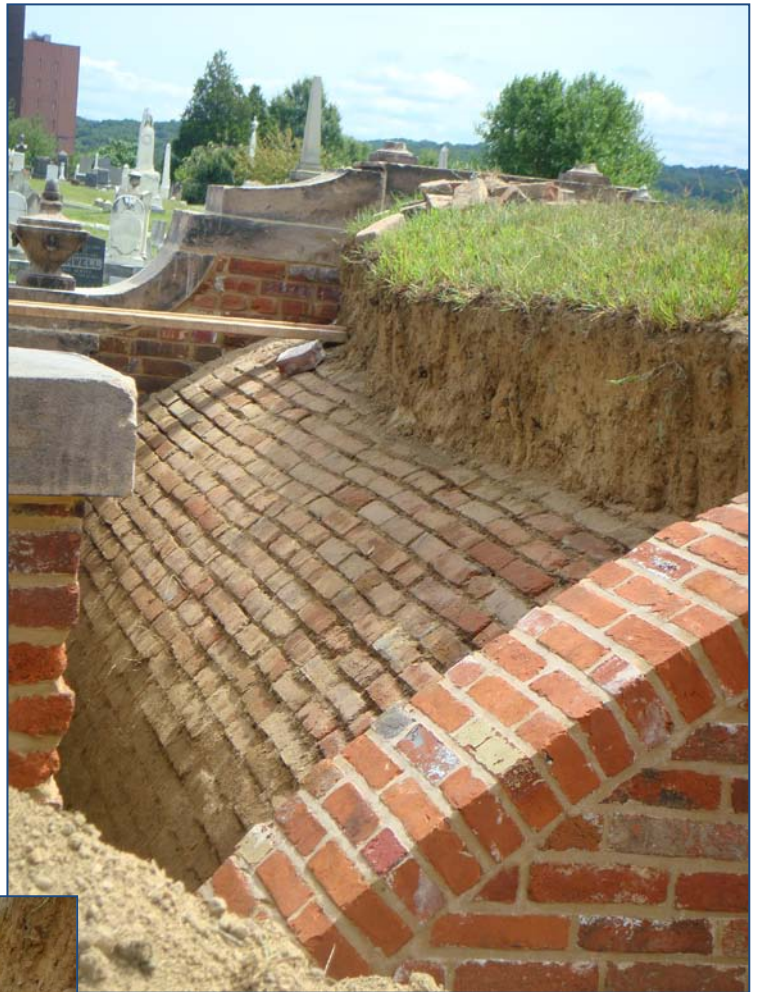
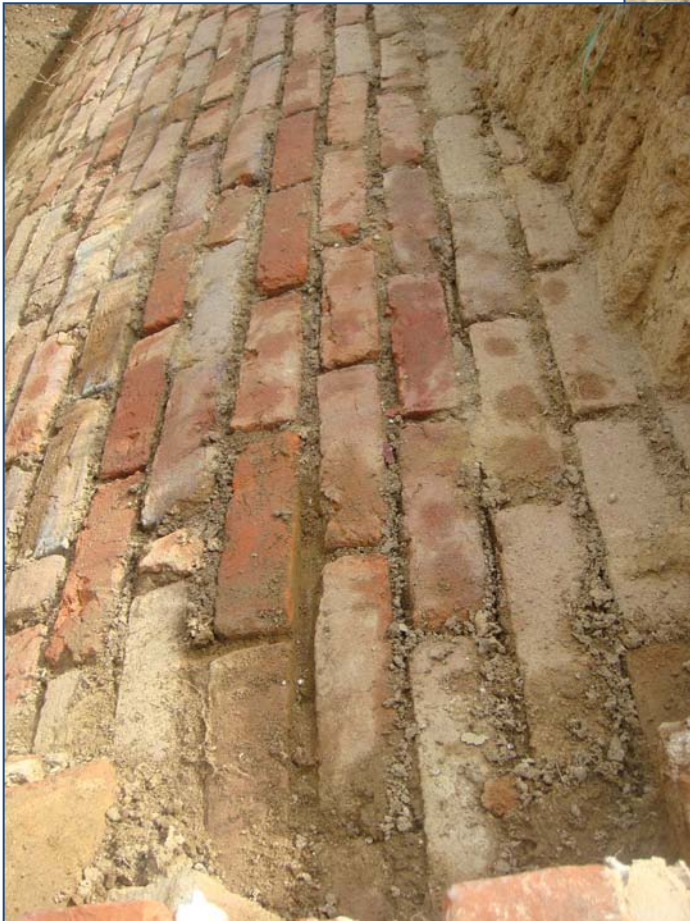
What we discovered was that *there is no mortar left between the bricks of the vault itself. It's just dirt.*

We've seen this problem before and, if unrepaired, leads to the collapse of the vault.

This condition was found in two of the three vaults and is expected to show up on the third as well. The dirt has to be removed and replaced with mortar, and then a top coating of parging material layered on to seal the vault roof.
